**Water Leakage Investigation  
7 King Street East  
Toronto, Ontario**

MTCC #1170 – The Metropole  
7 King Street East  
Management Office  
Toronto, Ontario  
M5C 3C5

Projectno. BRBS00066208F  
June 18, 2004

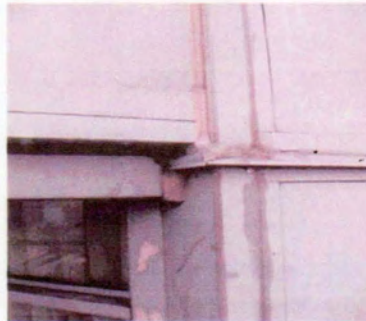
Photograph 1

- 1) The sealant at the [REDACTED] floor slab, window wall flashing, was noted to be discontinuous for the portion which returns below the underside of the balcony slab. Controlled amounts of water introduced at this area, resulted in water entry into the soffit area in less than one minute (see Photographs 1 and 2).

A metal flashing should be provided. This flashing would be sealed to the underside of the [REDACTED] floor, balcony slab. The flashing would extend below the suspended soffit level and project beyond the exterior face of the cladding. The intent of this angle would be to direct

any water which enters, through any of the potential sources demonstrated by Trow, to the exterior and not into the soffit space. The angle would need to be end-dammed (i.e. capped), and continuous for the exterior portion of the balcony perimeter. In addition, Trow would recommend that another 25 mm x 25 mm angle, also sealed to the underside of the slab, outside of this new flashing, to act as a drip edge to prevent water migrating across the underside of the slab and reaching the new flashing where it meets the concrete. The flashing would be left open (i.e. not sealed) at the lower exterior edge to provide free drainage to the exterior.

In addition to the above, Trow would also recommend that the demonstrated sources of water entry be sealed to reduce the number of potential sources. The suspended soffit, could then be repaired or fully replaced with an appropriate exterior gypsum board.

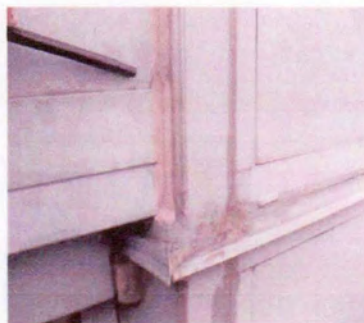
Photograph 3

- 2) Trow introduced water at the lower corner of the balcony slab edge cover and noted water entry into the soffit area. (see Photographs 1 and 3).

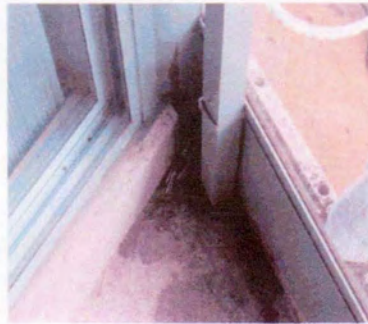
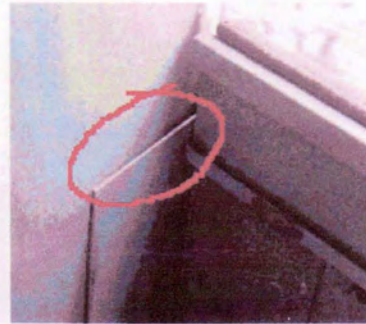
- 3) Water was introduced at the top edge, of the inside metal corner closure, installed between the inside surface of the balcony slab edge cover, and the outside corner post

of the adjacent window assembly. Trow observed water entry into the suspended soffit area within a minute (see Photographs 4 and 5). The top edge of the aluminum closure was noted to be unsealed.

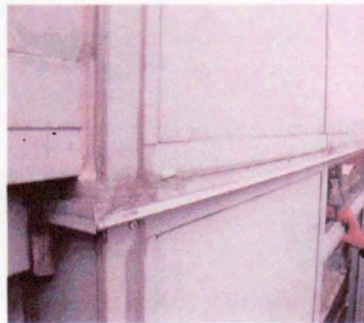
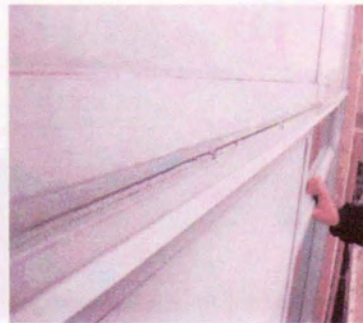
- 4) The metal slab edge cover is sealed to balcony, water-proof coating. It was observed that the sealant is discontinuous at the balcony guard rail, post locations. Trow introduced water behind the north post of the balcony guard, on the east elevation, and within one minute, water was observed entering the suspended soffit space below.
- 5) Trow observed, that the sealant installed between the top surface of the aluminum window wall flashing and the sill mullion of the spandrel panel at the [REDACTED] floor slab has failed cohesively (see Photographs 6 and 7)

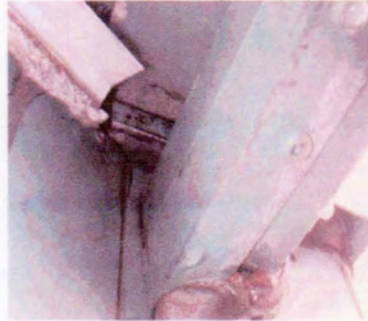
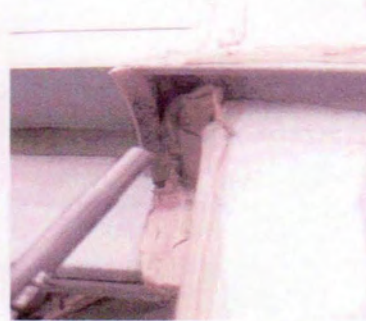
- 6) It was noted, that the metal corner closures and vertical mullions couplers for the window wall system at the balcony areas of Suites [REDACTED] have been needle beaded with clear sealant. The sealant was noted to have adhesively failed, at several locations.
- 7) It was observed, that the sealant application is discontinuous at the underside of the window wall flashing installed at the [REDACTED] floor slab, right-angle change at the balcony area. ( see Photographs 8 and 9).

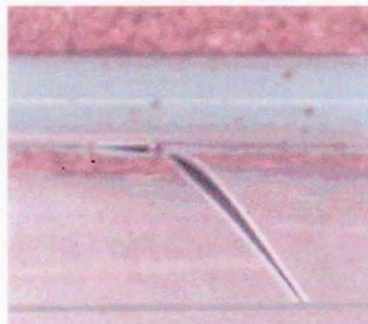
Photograph 10

- 1) Trow observed, 'oil-canning' of the slab edge covers on the west elevation of the balcony for Suite [REDACTED] (see Photograph 10)

The water penetration problem associated with the soffit of Suite [REDACTED] is similar to that of Suite [REDACTED] as noted in Section 4.1. As such, Trow would recommend the same repair procedure be implemented to prevent water penetration to the suspended soffit.

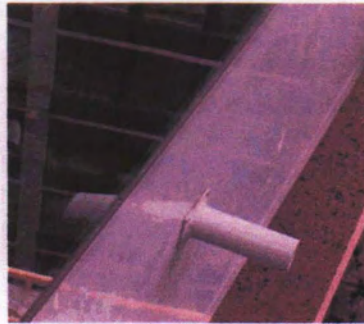
Photograph 11

- 2) Water was introduced at the top edge, of the inside metal corner closure, installed between the inside surface of the balcony slab edge cover, and the outside corner post of the adjacent window assembly (Suite [REDACTED]). Trow observed water entry into the suspended soffit area below, within one minute (see Photograph 5). The top edge of the aluminum closure was noted to be unsealed similar to that of Suite [REDACTED].
- 3) The interface between, the mounting plate of the balcony drain pipe and the exterior face of the balcony slab edge cover was noted to be unsealed. Trow introduced water

at the top edge of the mounting plate and noted water entry to the soffit space below (see Photograph 11).
