## THE METROPOLE

### Clothes Dryers' Inline Lint-Screens

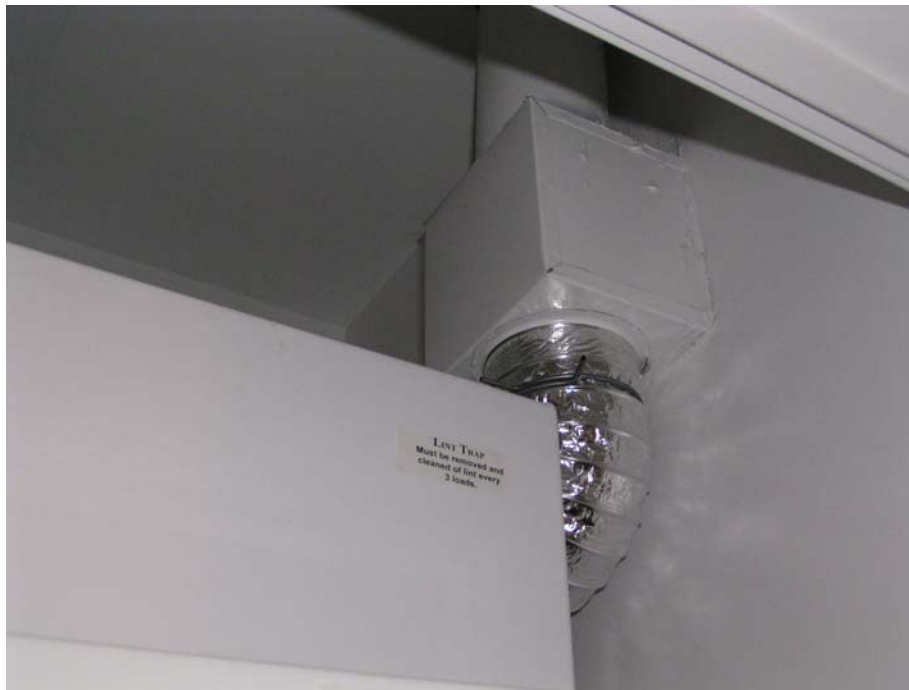
In the interim, though, residents are responsible for cleaning their both lint-screens. It is an easy and beneficial task, as the following pictures indicate. But where is the secondary lint-screen? The following picture shows the back of the lint-screen's housing. This is where the silver-coloured, fire-retardant exhaust-tube from the dryer enters the lint-screen's housing.

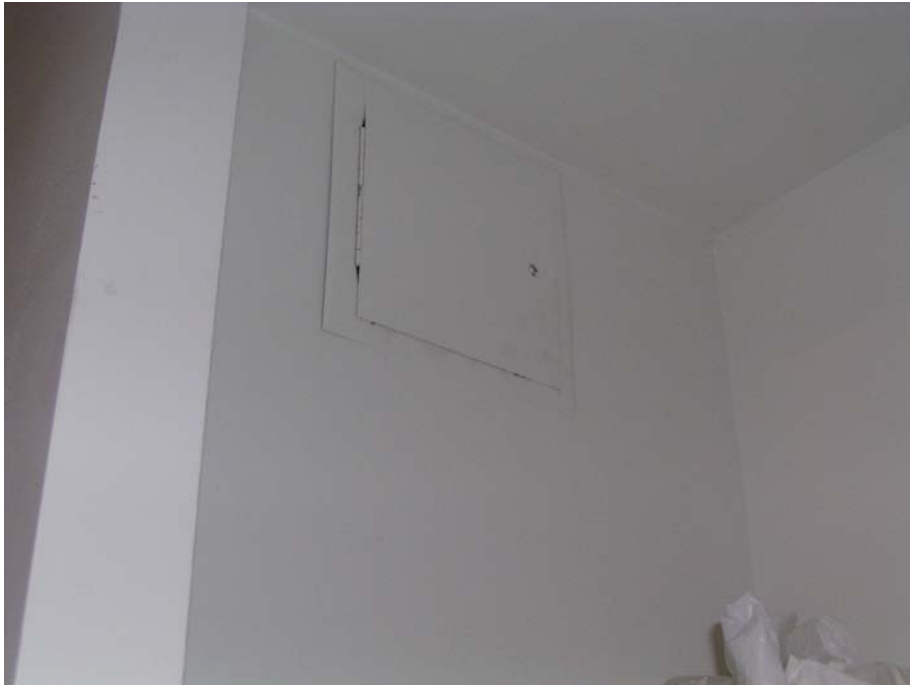
The next picture shows the front of the lint-screen's housing. This includes the lint-screen's access-door. What tools are necessary for opening that door?

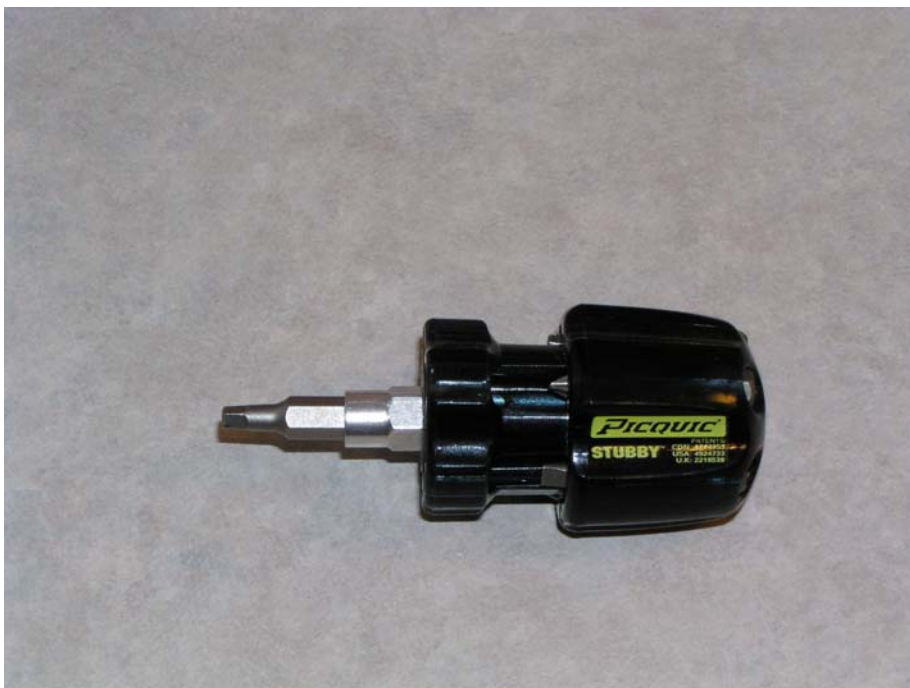
A Robertson #2 screwdriver, shown below with additional bits in the handle, will open the door.

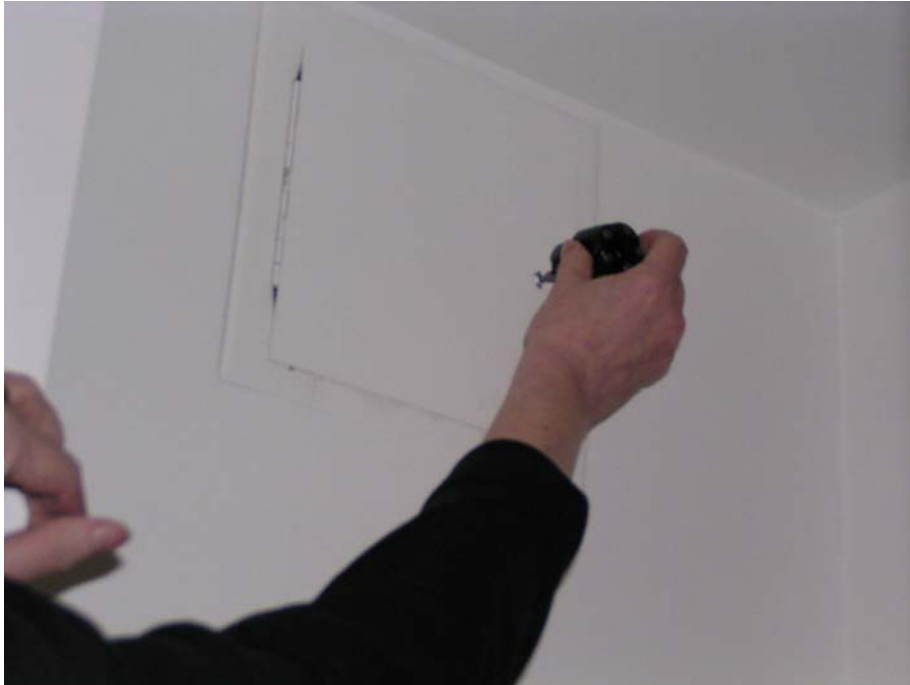
This picture shows where to use the screwdriver to open the lint-screen housing's access-door.

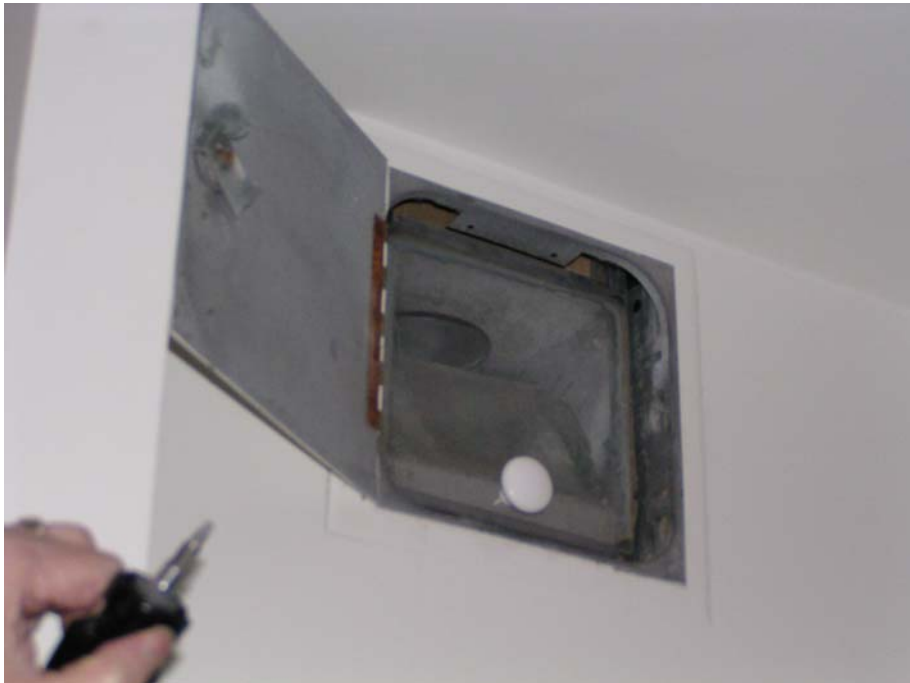
The next picture shows the access-door open. Note that screen is sitting higher. This reflects the fact that it is dirty. Therefore, it obstructs airflow, and exhaust air pressure has raised it slightly.

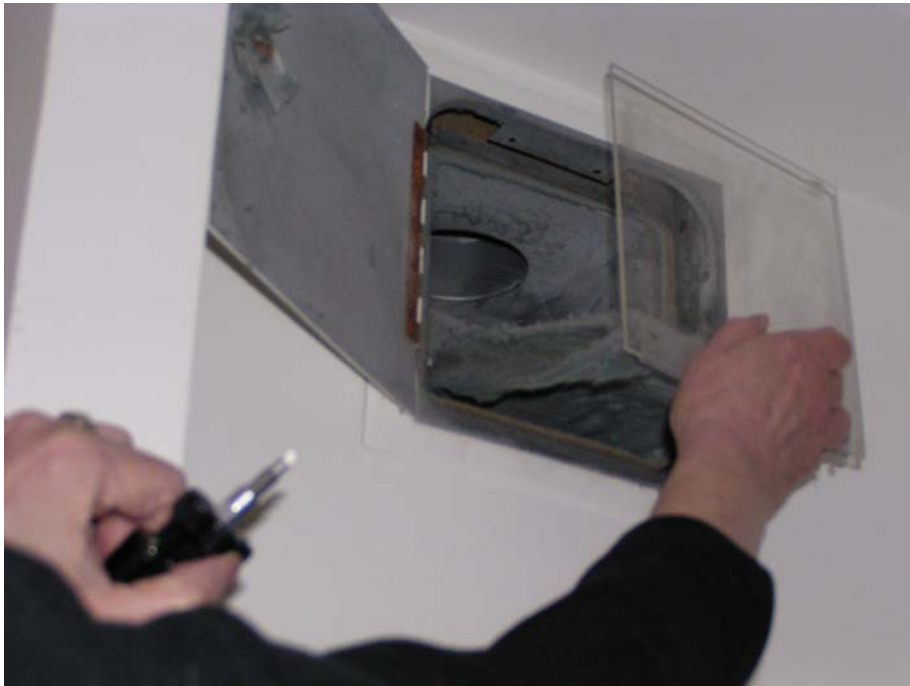
The next picture shows a resident lifting the Plexiglas door clear of its bottom bracket. The resident can then easily pull the Plexiglas door (with screen attached) from its top bracket.

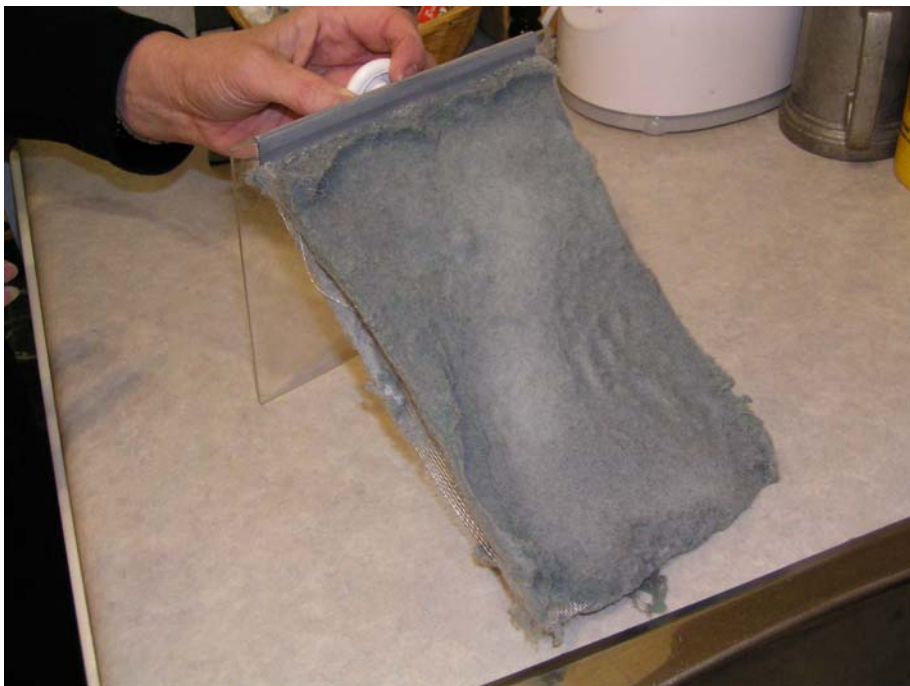
This picture shows the lint-accumulation on the lint-screen's underside. It is about one month's accumulation. Except for creating this mini-manual, cleaning would/should be more frequent.

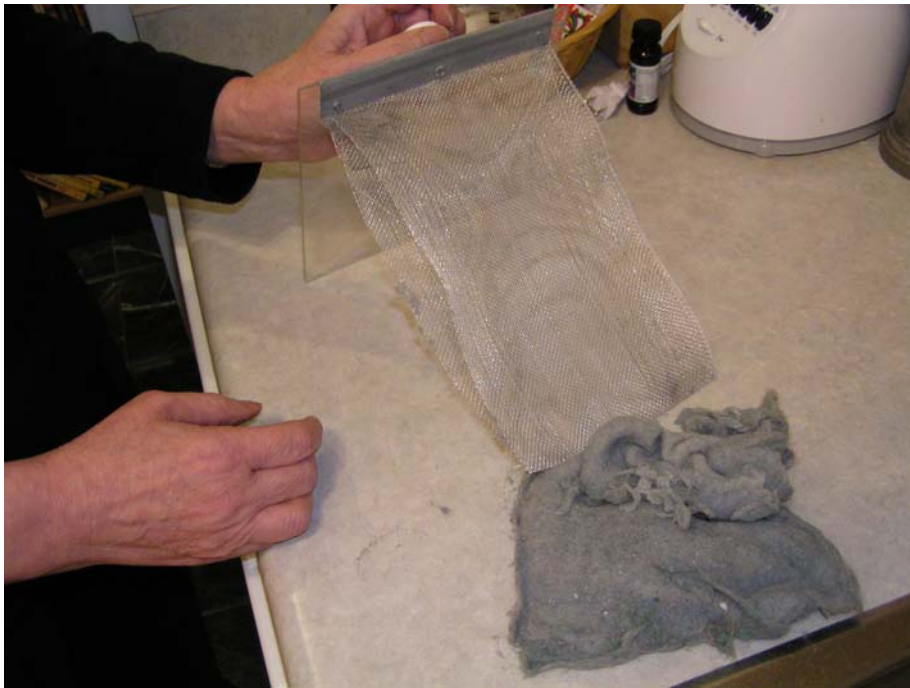
The next picture shows a clean lint-screen, ready for reinstallation in the lint-screen's housing. Nearby, is the pile of newly-removed lint. It obstructs the secondary fan, and it is a fire-hazard.

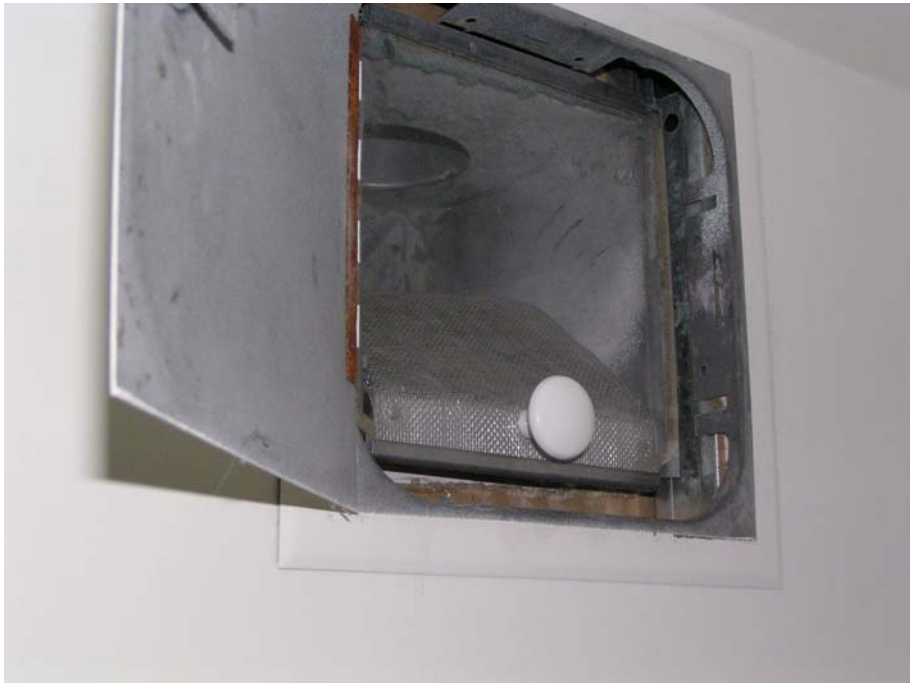
Now, we see the cleaned lint-screen in place, ready for closure of the access-door.
